Manhole Inspection Summary

Manhole # S45I__019MH

Insp Date: **7/30/09 10:26 AM**

Location Address: **1919 GOUGH ST**

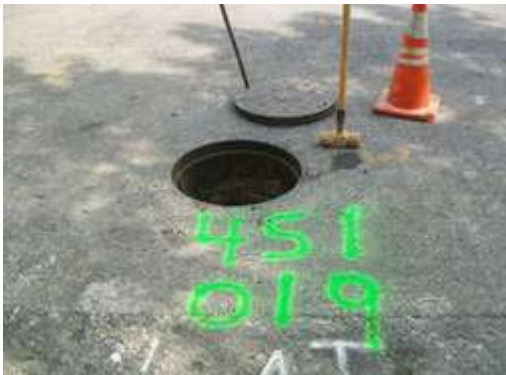
Miscellaneous

PAVEMENT MARKED

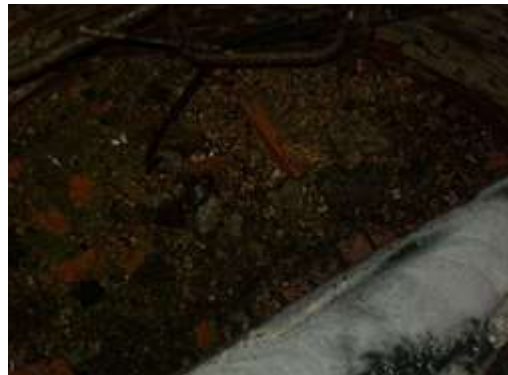
Defect 2

Condition: ☐ Sound ☐ Cracked ☐ Root Intrusion ☐ Deteriorated ☐ Leaks ☒ **Debris**

DEBRIS ON BENCH

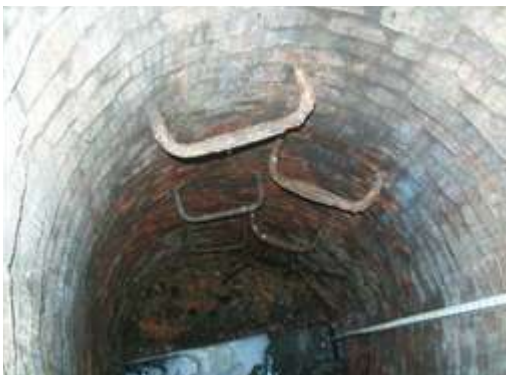
Defect 1

Count: **6** Missing: **0** ☒ **Corroded**

CORRODED STEPS

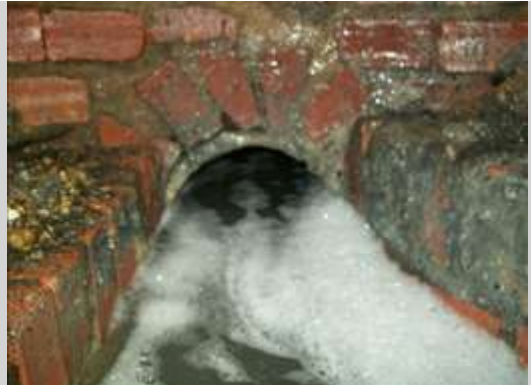
12 O'Clock Outflow

Pipe Height: **8.4** (in.) Rod and Bar (Angled)
Pipe Material: **Clay** ☐ Pipe Lined
Invert Depth: **11.37** (ft.) Flow Characteristics: **Slow**
Deposits: ☒ None ☐ Mud ☐ Sludge ☐ Debris ☐ Grease
Silt Depth: **0** (in.) Deposits Extent:
Infiltration: **None** Pipe Seal Cond: **Cracked**

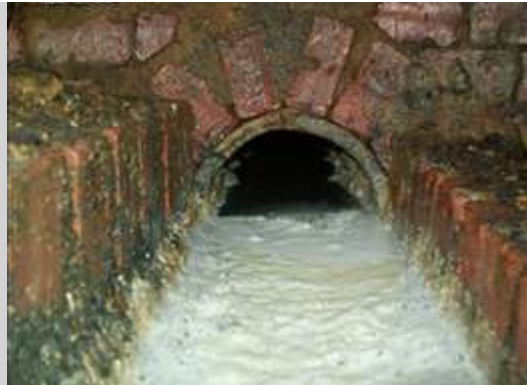
6 O'Clock Inflow

Deposits: ☐ None ☐ Mud ☐ Sludge ☐ Debris ☒ **Grease**

Silt Depth: **1** (in.) Deposits Extent: **Light**

Infiltration: **None** Pipe Seal Cond: **Cracked**
